# Veterans Administration Hospital (44)

13000 Sayre Street, Los Angeles County

**ROY G. JOHNSTON**

*Brandow & Johnston Associates  
Los Angeles, Calif.*

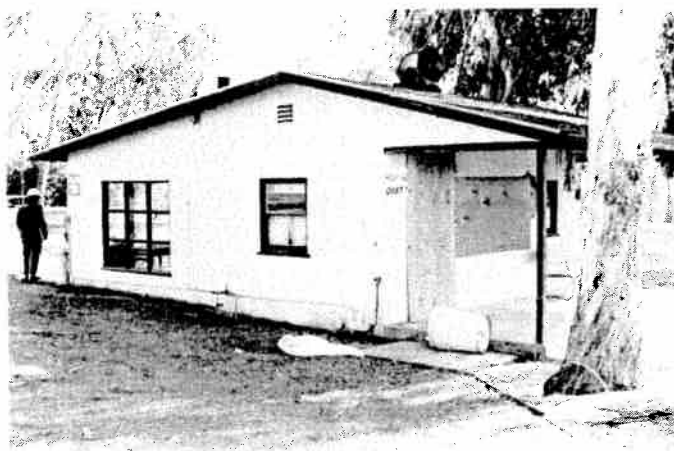
*Figure 34.—Veterans Administration Hospital. Unit 58.  
North elevation.*

Unit identification number	Year constructed	Structural classification type	Inspection observations
55.....	1950...	12-inch-deep tank with reinforced concrete walls.	No apparent damage was observed.
56.....		Slab-on-grade.	Do.
57.....		II.....	Structure was covered with debris and could not be inspected.
58.....	1957...	IV.....	Frame was essentially intact. No apparent damage was observed (fig. 34).
T-7.....	1947...	IV.....	Frame was essentially intact. No apparent damage was observed.
T-8.....	1947...	V.....	Do.
T-10.....	1947...	V.....	Do.
T-12.....	1948...	V.....	Do.
T-13.....	1947...	V.....	Do.
